# Manhole Inspection Summary

Manhole # S19M\_\_012MH

Insp Date: **4/1/08 9:19 AM**

**Location** Address: **513 pulaski-payson alley**

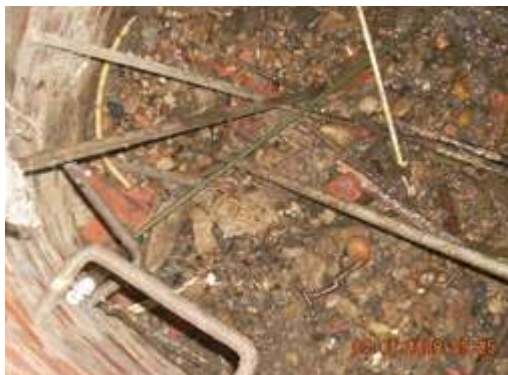
Defect 4

Condition: ☐ Sound ☐ Cracked ☐ Root Intrusion ☐ Deteriorated ☐ Leaks ☒ **Debris**

debris in terminal channel

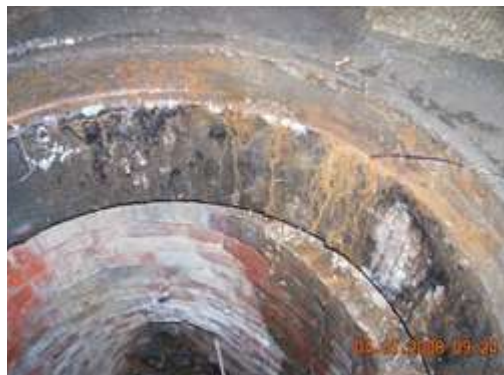
Defect 3

Infiltration: ☐ None ☒ **Joint** ☐ Cracks ☐ Mortar ☐ Roots ☐ Wall

inflow evidence, infiltration @ chimney/frame joint

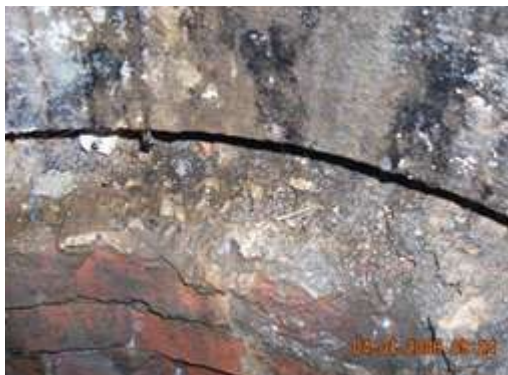
Defect 2

Condition: ☐ Sound ☐ Cracked ☐ Root Intrusion ☐ Loose Brick ☒ **Deteriorated**

deteriorated chimney

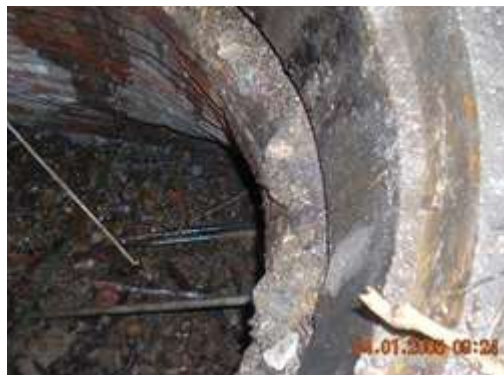
Defect 1

Offset: **1** (in.)

Infiltration: ☐ None ☐ Joint ☐ Cracks ☐ Mortar ☐ Roots ☒ **Wall**

frame offset, infiltration @ corbel wall (dripping)

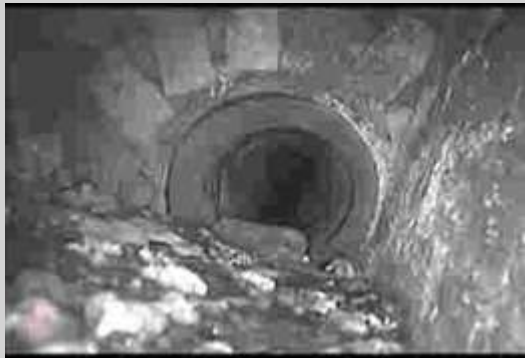
12 O'Clock Outflow

Deposits: ☐ None ☒ **Mud** ☐ Sludge ☐ Debris ☐ Grease

Silt Depth: **2** (in.) Deposits Extent: **Medium**
